Observation and auscultation of the geotechnical behaviour of a slope in an open cast mine influenced by old underground mining (South-western part of France)

ABSTRACT : The final slopes of a French open pit mine of the "Charbonnage de France" company which final depth will be 300 metres, have been designed after a standard geotechnical survey. This one has taken into account the geomechanical, hydrogeological, structural parameters as well as the "decohesion", induced by former mining subsidence. However some slopes can locally present risks of slipping (increasing with the depth of the pit) induced by old underground mining.

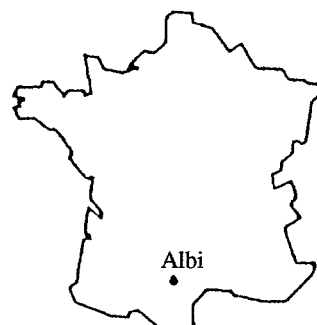
Fig. 1 : Situation

The Sainte Marie open pit is a coal mine of the Mining Unit of Tarn, H.B.C.M. (Houillères du Bassin Centre Midi), in the south-western part of France, near Albi (Fig. 1). In this area a large amount of coal has been exploited by underground mining. This pit was designed in order to exploit the coal remaining around the shaft (Saint Marie shaft) of an old underground mine situated in the basin of Carmaux.
